CALIFORNIA DIVISION OF MINES AND GEOLOGY

FAULT EVALUATION REPORT FER-102

December 15, 1980

Hayward Fault (Oakland segment).

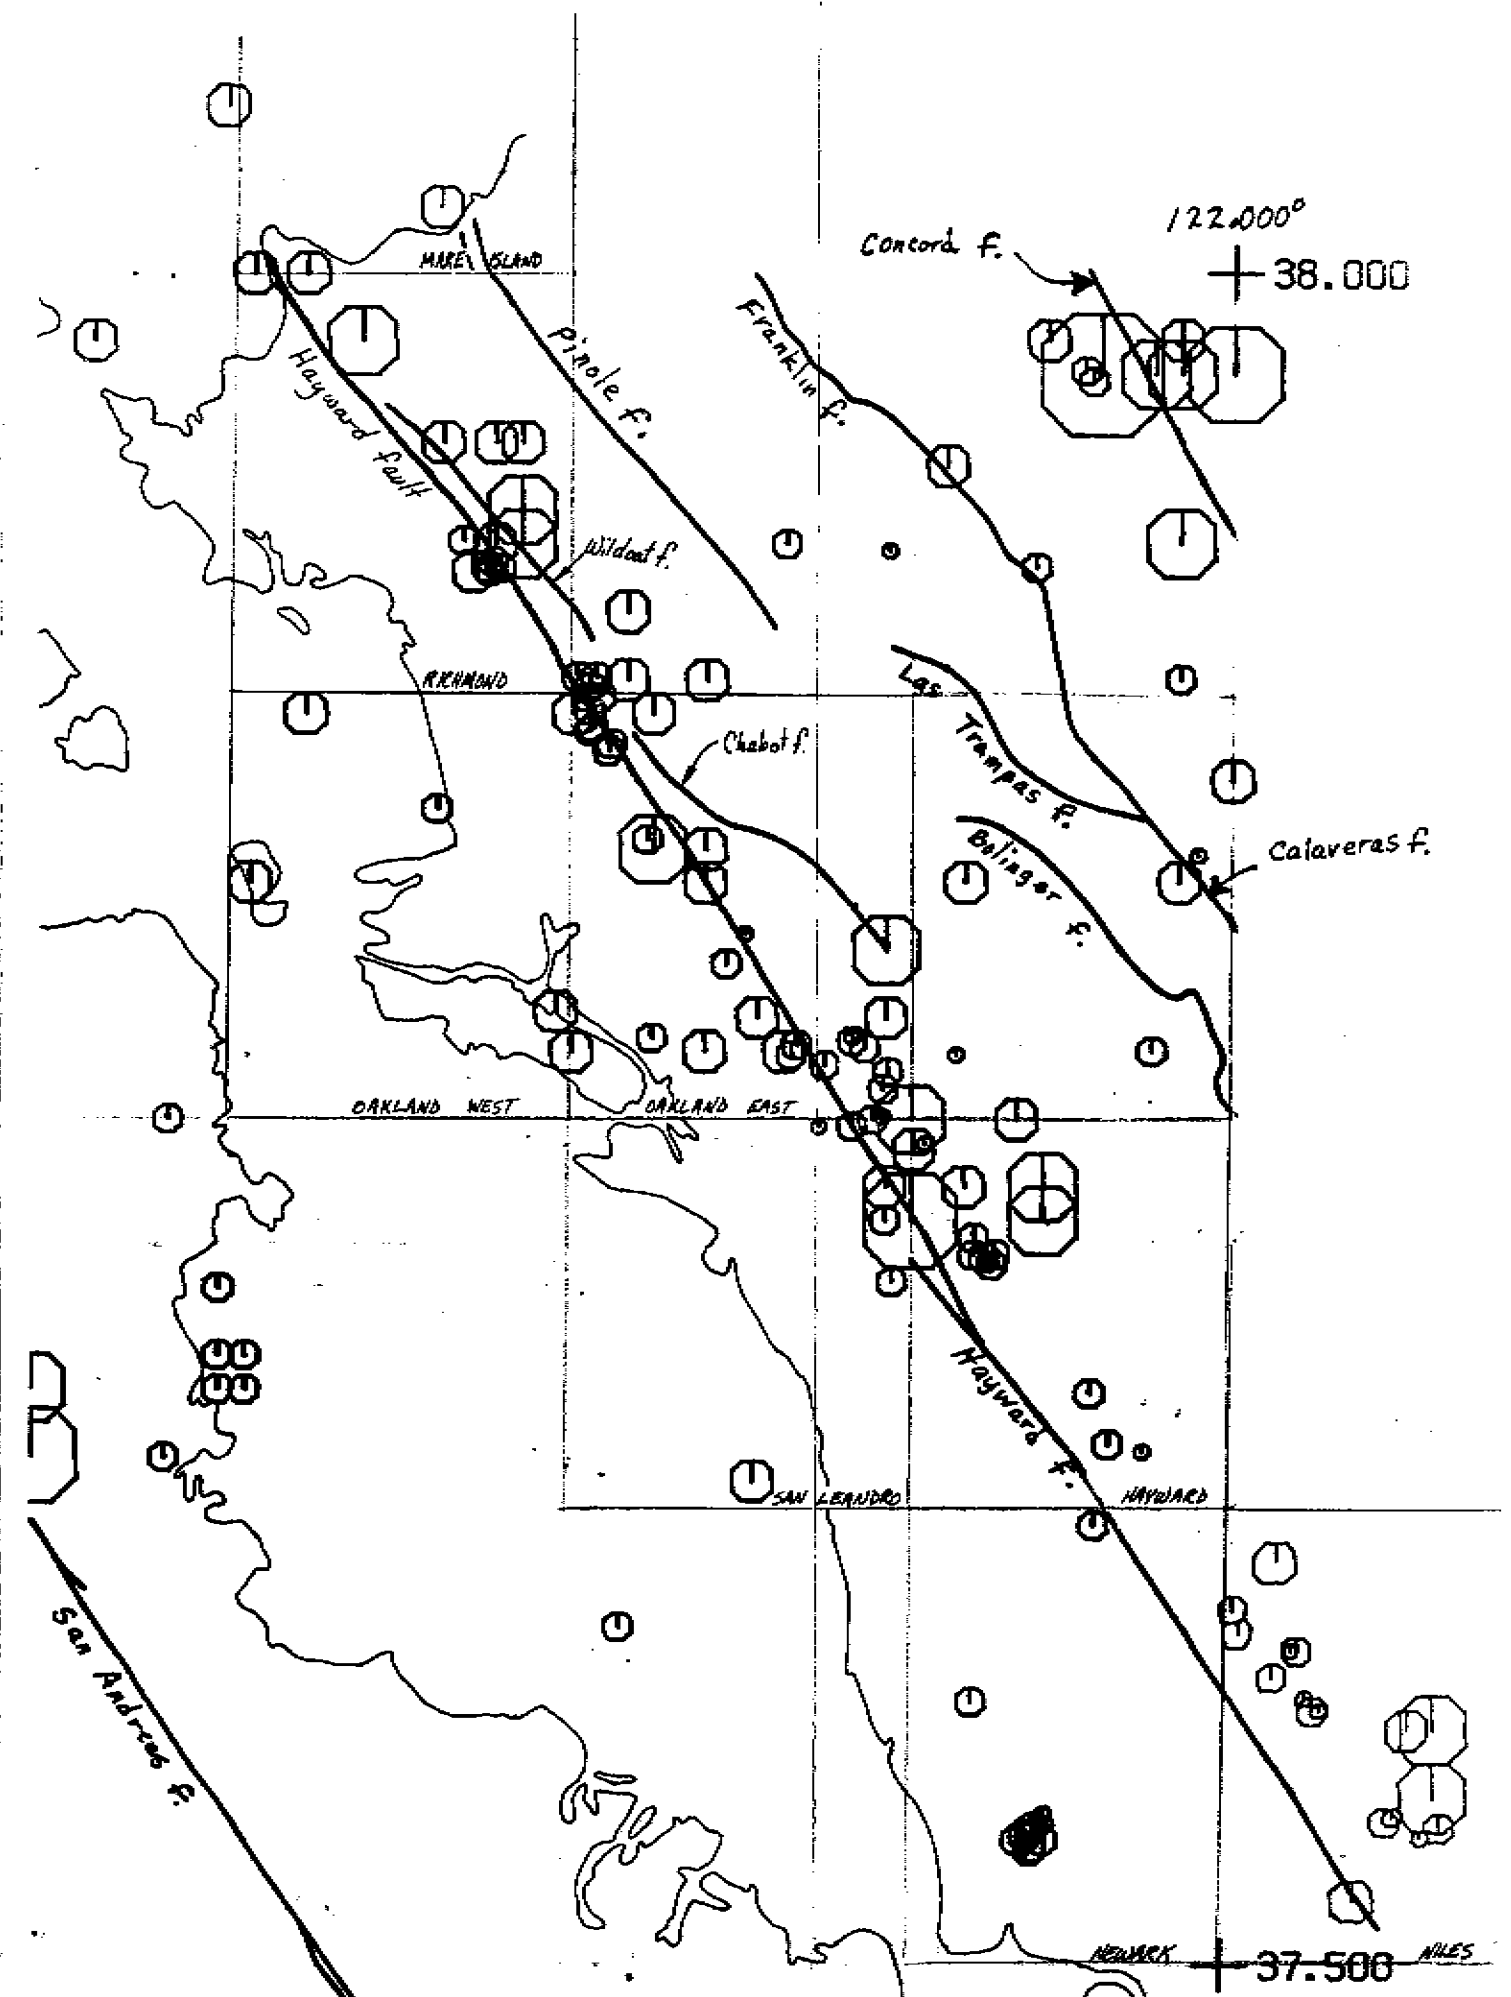
Figure 7. Locations of "A" quality earthquake epicenters in the vicinity of the Hayward fault from Point San Pablo to Niles (after Real, et al., 1978) and principal faults in the area.

The Hayward fault has long been documented as seismically active. As noted earlier, major earthquakes occurred in 1868 (Lawson, and others, 1908) and 1836 (Loudnerback, 1947). Real, et al. (1978, see Figure 7) have documented a zone of seismicity along the Hayward fault.
